BUREAU OF SHIPS GROUP  
TECHNICAL INSPECTION REPORT

Operation Crossroads, U.S.S. SARATOGA (CV 3)

TEST BAKER

OPERATION CROSSROADS

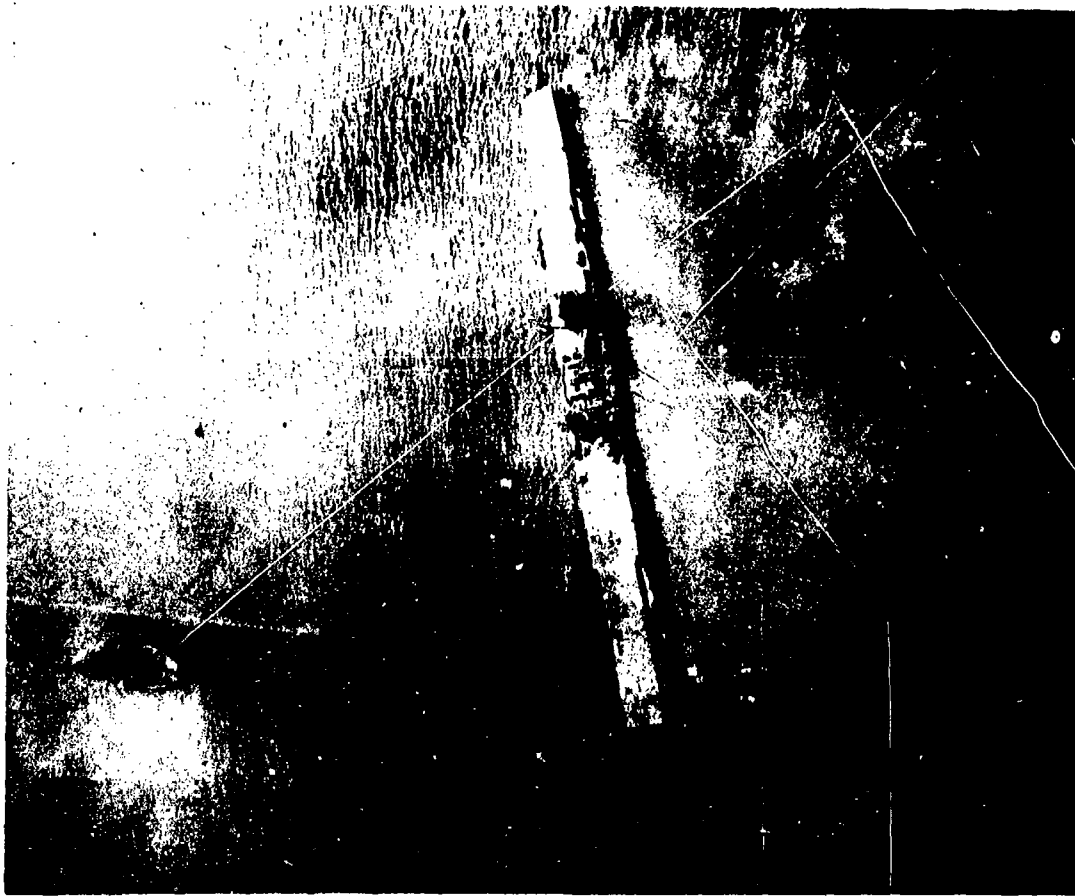
The greatest damage to the flight deck reported by the divers was at the stern of the ship. The flight deck is dished from approximately 15 feet forward of the after edge to about frame 130. This indentation which can be seen in photographs on pages 15 and 19 slopes forward and downward to a depth of about 12 feet at frame 130. Transversely it extends between the port and starboard outermost longitudinal bulkheads. The deepest indentation is midway between the two bulkheads. This indentation is gradual with no abrupt breaks or bends. There is no indication that the steel deck has been ruptured but the wood decking has been splintered and broken as shown in photographs on pages 32, 33 and 34.

DB-CR-53. PBM "D" 4/25 July 46/8 1/4" obl 1700'. Print #87. Topped portion of SARATOGA's stack. Note second drip pan missing on after flight deck.

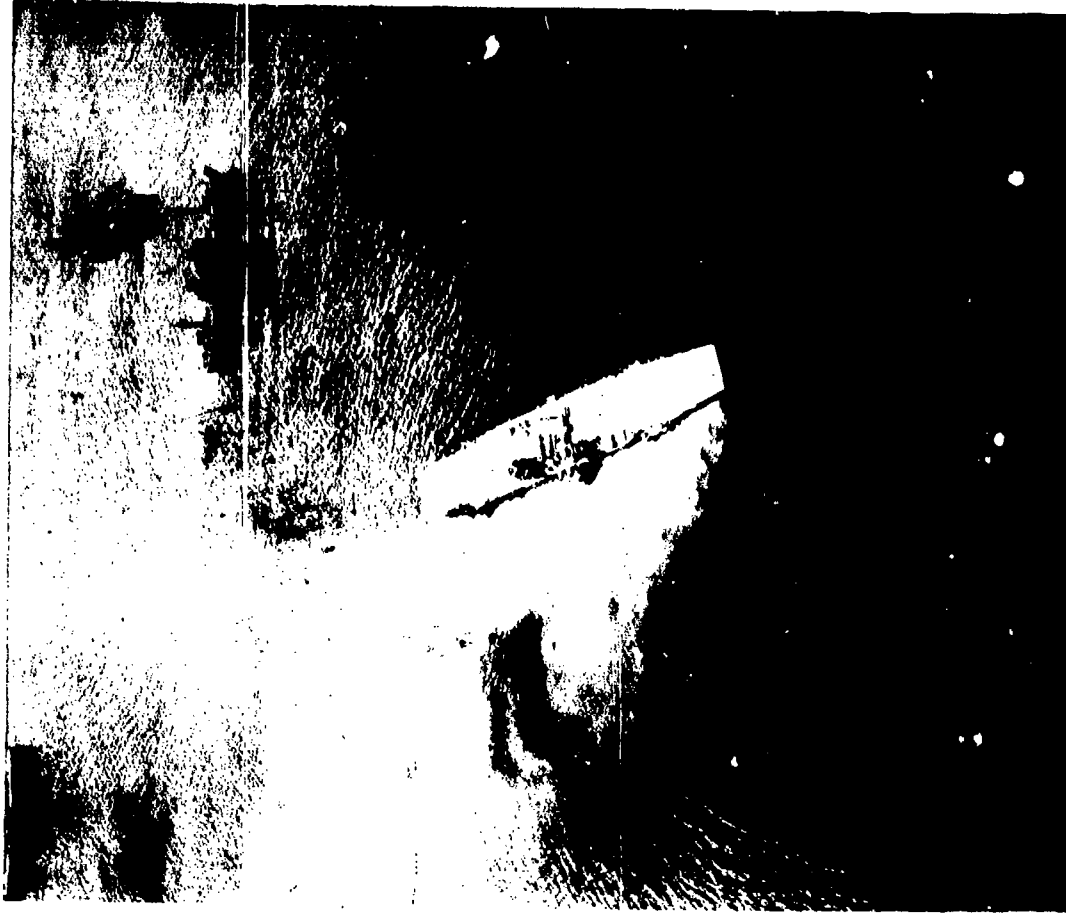
Forward of frame 130, the only damage reported by the divers and visible in photographs on page 16, 19 and 20 was the collapse of the forward elevator platform. The platform was dished downward diagonally from the forward port to after starboard corner. The port side of the platform appears in the photographs to be below the level of the flight deck whereas the starboard side appears to be above this level.

The stack was split into two sections. Three quarters of the stack can be seen on the deck in photographs 15, 18, 19 and 20. The remaining portion of the stack stands erect but is twisted about 20 degrees counter clockwise. (See photographs on pages 16 and 19).

DB-CR-53. PBM "D" 4/25 July 46/1 1/4" obl 1700'. Print #57. Starboard bow view of SARATOGA after Test B prior to actual submergence.

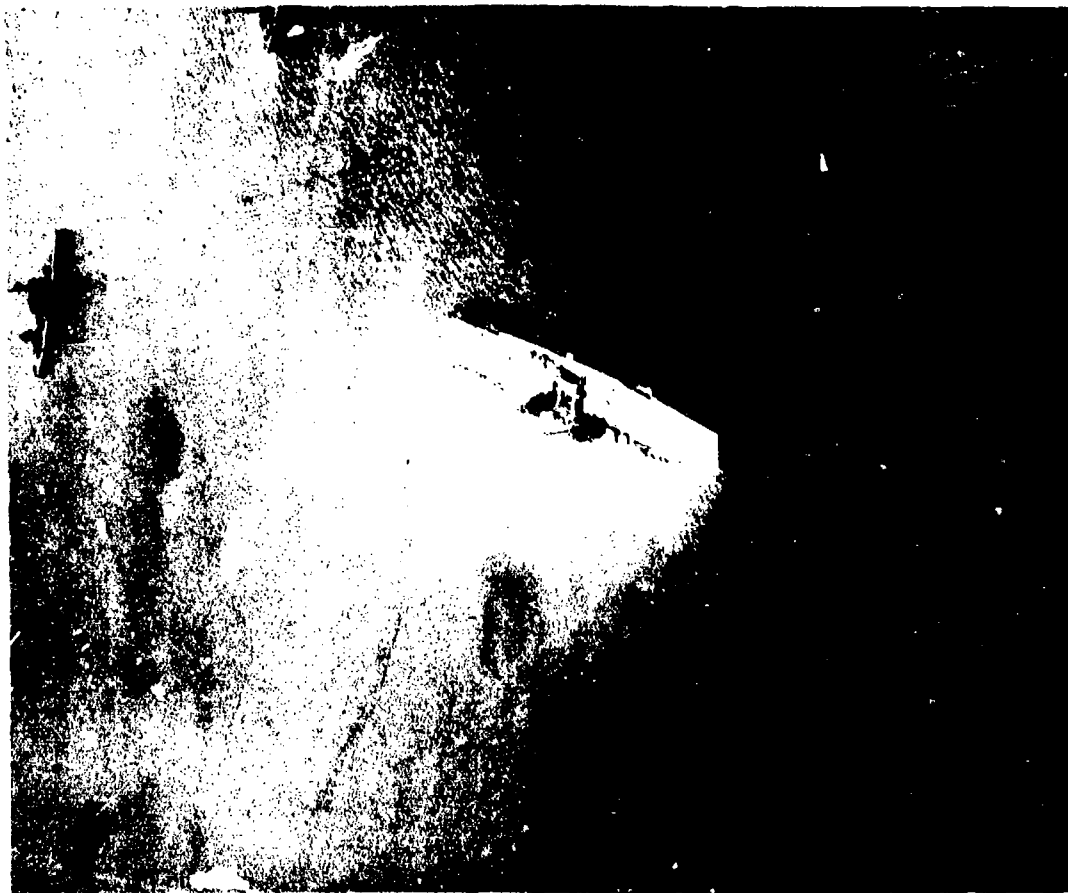
The top foremast was broken off above the SK radar platform. (See photographs on pages 17 and 18). The stub mast as shown in photograph on page 20 has been bent to port.

DB-CR-53. PBM 'D' 4/25 July 46/8 1/4" obl 1700'. Print #58. Port bow view of SARATOGA.

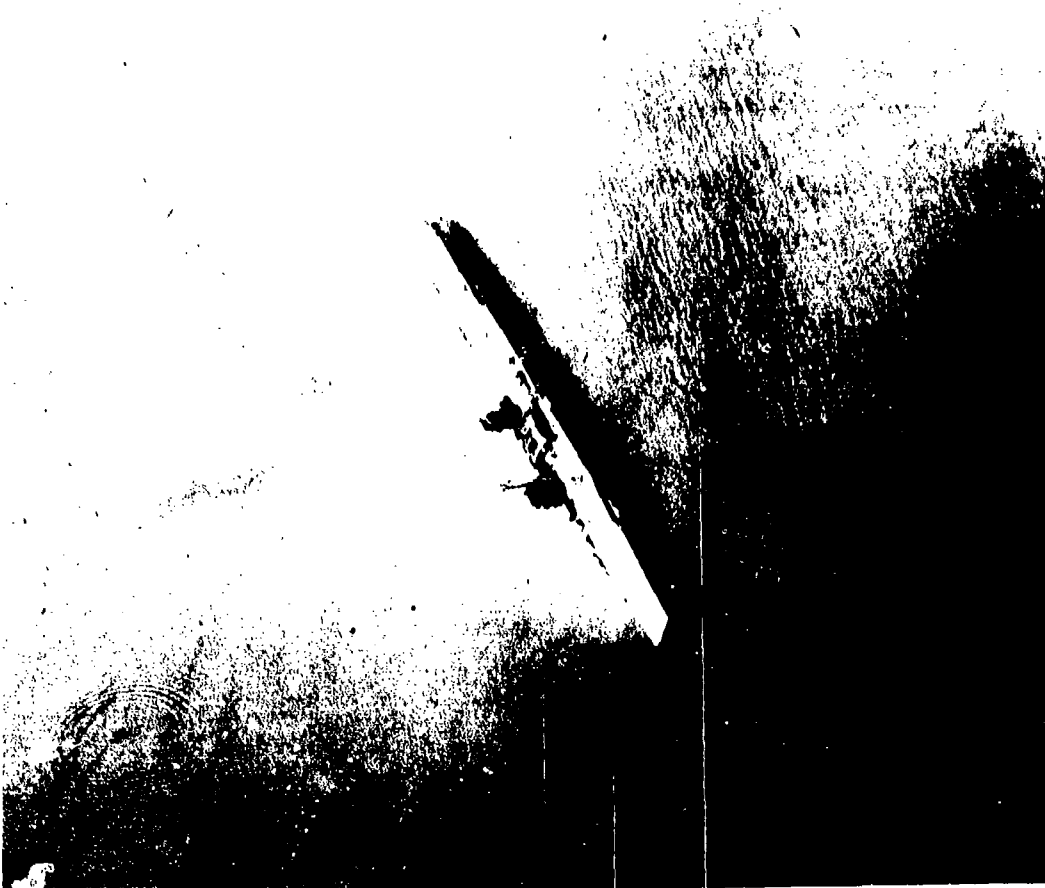
Part of the stack was toppled over onto the flight deck. Most of the Army equipment, the airplanes, one of the drip pans installed for an airplane and some instrumentation were missing from their installed positions on the flight deck. They may have been blown off the ship or washed over the side by the descending water column.

DB-CR-53. PBM 'D' 4/25 July 46/8 1/4" obl 1700'. Print #84. Cleared deck of SARATOGA. Compare with photo on page 13.

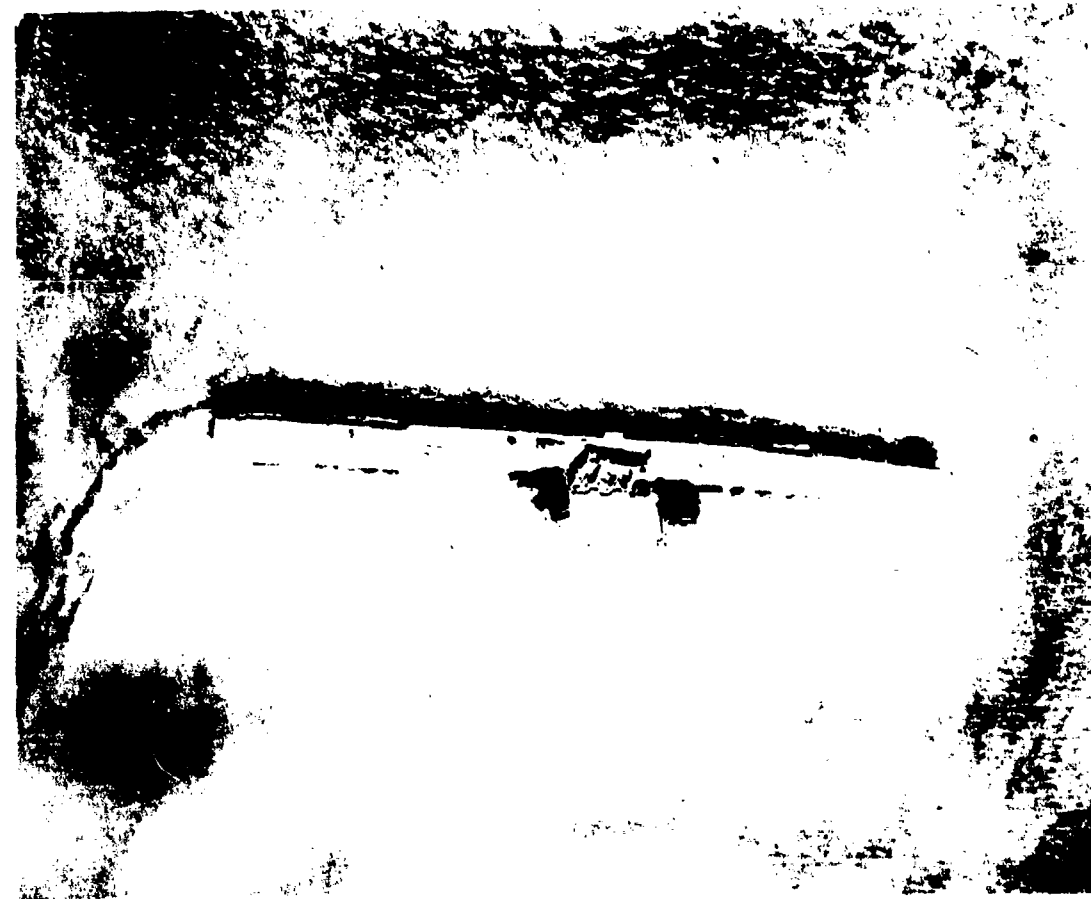
The fire control equipment was completely immobilized. The guns, left on the ship for test purposes, as viewed from air and by the divers were apparently in good shape. Gun galleries bordering the flight deck were not damaged. The MK 12-22 fire control antennae cannot be seen in photographs on pages 18 and 19.

DB-CR-53. PBM 'D' 4/25 July 46/8 1/4" obl 1700'. Print #70. View of damaged forward elevator. White line on after flight deck marks outer starboard limit of deck depression.

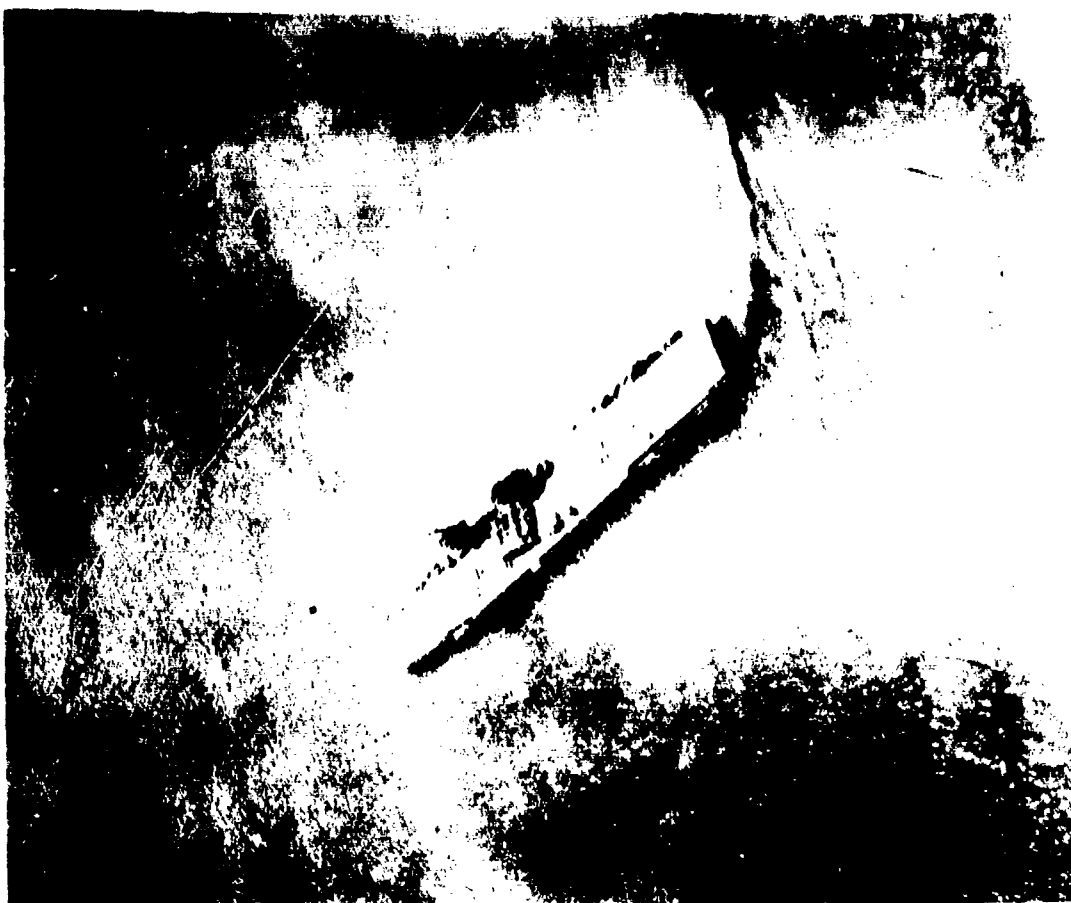
The divers reported that the platform which covered the original number two elevator is missing. This platform later was reported to have been found on the starboard quarter of the ship. A drip pan, formerly installed under the completely fueled airplane at frame 138, was blown out of its location. (See photograph on page 15). This may be the reported elevator platform. Furthermore the flight deck appears intact where the number two elevator was formerly located. See photographs on pages 18, 19 and 20.

DB-CR-53. PBM 'D' 4/25 July 46/8 1/4" obl 1700'. Print #71. Stern view of SARATOGA.
